## THE ANALYSIS OF MECHANICAL DAMAGE OF COMMON RAIL INJECTORS

### Summary

The paper presents the causes and effects of corrosion, destructively affecting the technical condition and operational reliability of injectors used in Common Rail supply systems. In addition, the analysis was made regarding damage to compression-ignition (diesel) engines with common-rail supply systems occurring in the operation of injectors caused by external and internal operating factors. Studies on injection equipment wear were carried out with the use of Hitachi S-3400 scanning electron microscope. Photos were also taken at the repair workshop of the needle surface and the socket using D.O. Smart digital microscope with specialized fibre optic lighting. Worn components were analyzed, indicating the elements most frequently subject to destructive processes. The possibilities of diagnosing subassemblies of Common Rail injection systems were indicated.

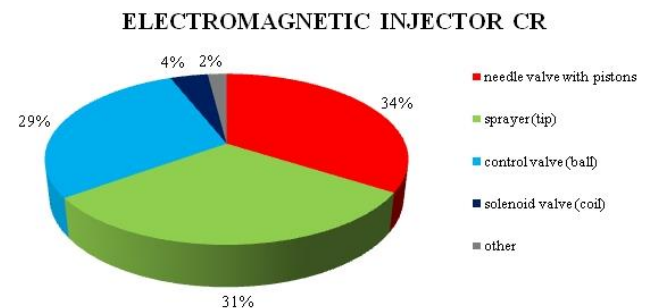
The results of the analysis indicate that corrosion is a significant factor affecting the failure rate of CR systems. As shown in Fig. 3, the most common type of damage to

injectors of this type was: 34% needle valve, followed by 31% nozzles, 29% control valves in the third place, 4% solenoid valves, and 2% others.

Fig. 3. Statistics of injectors failures used in high pressure systems CR

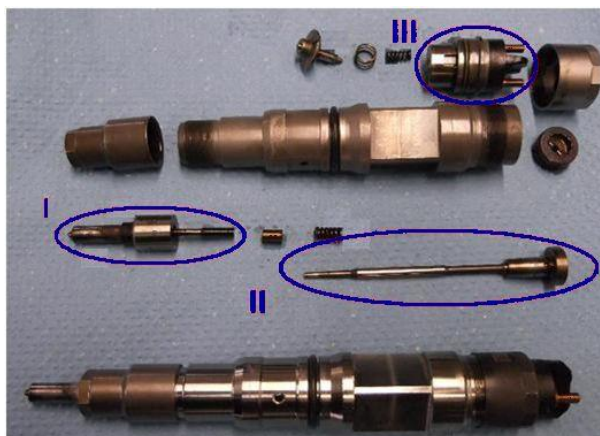
One of the most frequently detected damage in modern CR injectors is the abrasive wear of a precision pair, which

is a needle with a nozzle, and a needle valve, which is shown in Fig. 4 I and II.

Fig. 4. Components of Common Rail electromagnetic injectors subject to wear, where: I – nozzle, II – needle valve, III – solenoid assembly with armature

The first symptoms indicating a deterioration of the interoperation of these components are observed when the engine is on idle (vibrations, noisy combustion process). The fault can be detected at the low pressure set point on the test bench [3], and it concerns the construction of drive units with a relatively low operating mileage. Possible causes include: use of poor quality fuels (too low lubricity) or with too high a share of the vegetable component, improper filtration [1, 2]. The acceptable value for solid contaminants in the fuel is determined according to PNEN 590/2006 to be below 24 mg/kg of fuel. It should be noted that this value was also in force during the widespread use of conventional injection systems and has not changed. Fuel quality, including mainly water and sulphur content, has a significant impact on the intensity of destructive processes. The literature [1, 5, 7] also points to other reasons, including high pressures and temperatures in the combustion chamber, ballistic phenomena, turbulent liquid flow, and cavitation erosion.

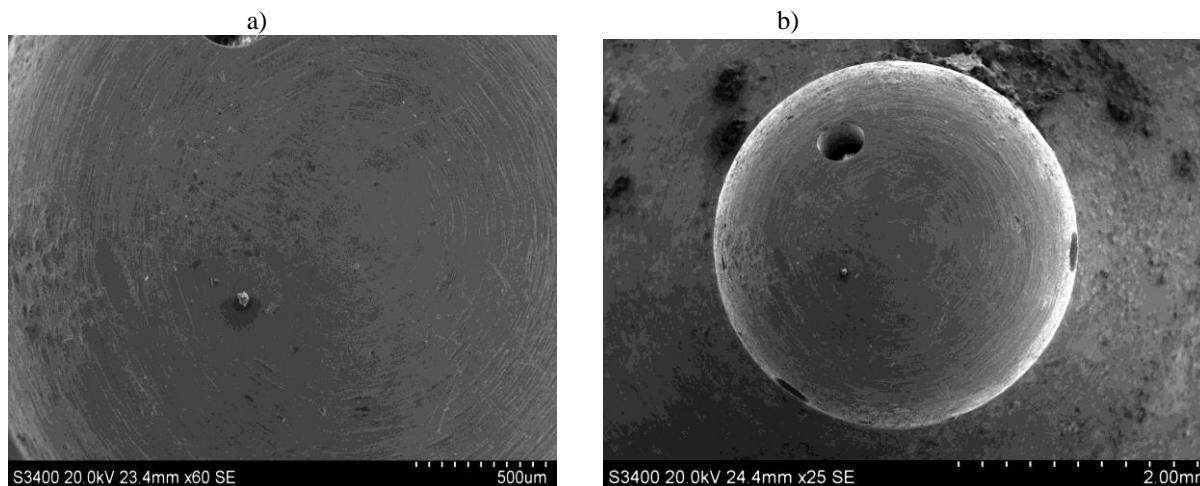
The test results showed a visible effect of high temperature and pressure on the burnt tip and marks of scorching on the needle. The photographs of the nozzle tip were taken as part of metallographic tests at the Materials Laboratory (LabMaPL) of the Department of Materials Science at the Rzeszow University of Technology with the use of the Hitachi S-3400N scanning electron microscope. At magnifications of 25x, 60x, wear was found, which is related to high thermal loads causing changes in the internal structures of the metal (Fig. 5).

In addition, at a magnification of 25x and 60x, the impact of high temperatures at the tip of the nozzle is visible, leading to changes in the surface structures and melt marks. There are also uneven nozzle bores and damage to nozzle bore edges due to erosion.

Fig. 5. A photo of the tip of the nozzle at 25x magnification (a) and 60x (b) [16]

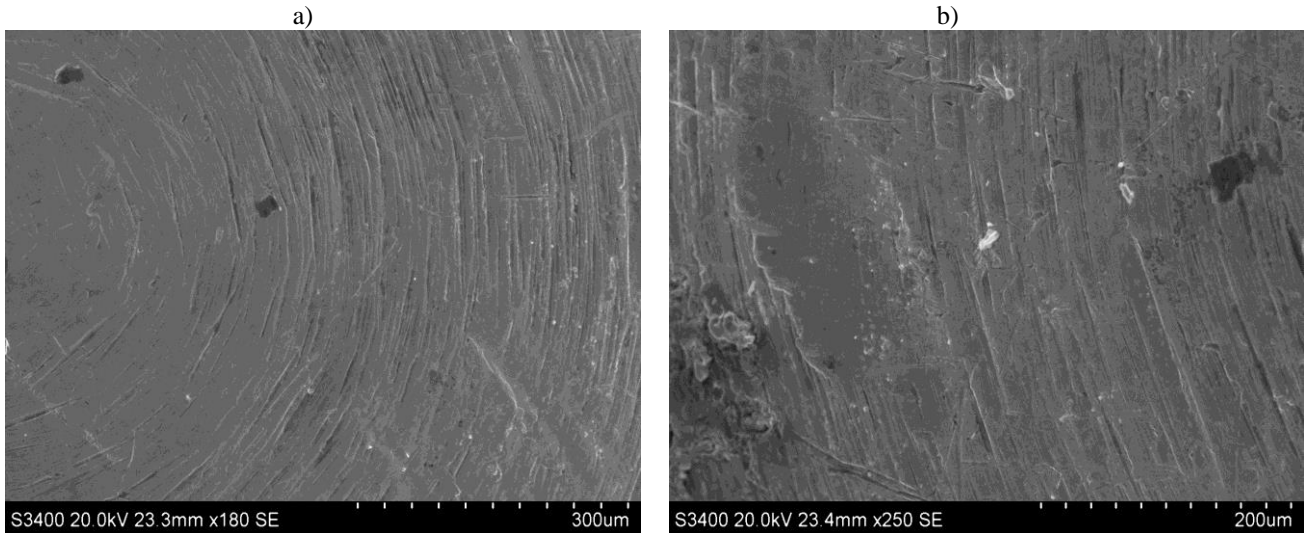
At a magnification of 180x and 250x, the tip of the nozzle shows a change in surface structure, the presence of micropores and micro-cracks of varying course and intensity (Fig. 6) below is the wear in control valve seats and on the contact surface of the valve plug. Microscopic images of significant changes in the conical needle and socket surface were taken with the D.O. Smart digital microscope with specialized fibre optic illumination. Damage to the ball valve seat causes an increase in the overflow rate, which leads to incorrect operation of the injector.

Fig. 6. A photo of the tip of the nozzle at 180× magnification (a) and 250× (b) [16]  
 Rys. 6. Zdjęcie końcówki rozpylacza w powiększeniu (a) 180 × i 250 × (b) [16]

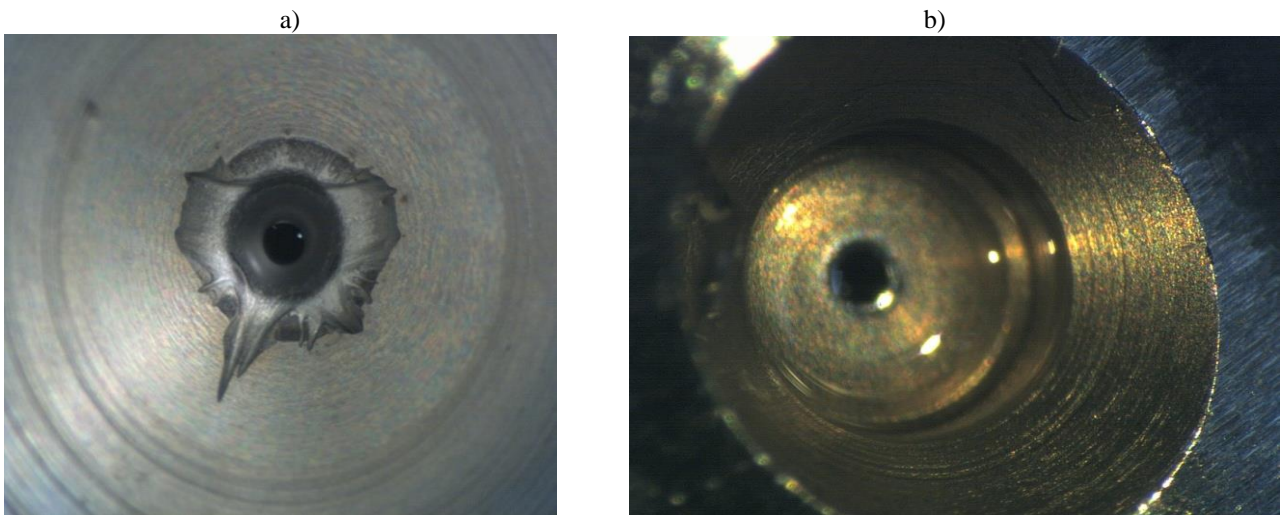
The research has shown that the greatest damage concerns the sealing association of the seat and the nozzle cone, where deformations occur as a result of the dynamic action of the needle. Figs. 7-12 shows examples of such damage. Fig. 10 shows the needle and injector tip from the Common Rail system, where traces of local overheating can be seen on the surfaces.

Fig. 7. Unusual surfaces of control seats - erosion of the Bosch injector control valve seat (a), worn surface of the control valve seat (b) [16]  
 Rys. 7. Nietypowe powierzchnie gniazd sterujących - erozja gniazda zaworu sterującego wtryskiwacza firmy Bosch (a), wypracowana płaszczyzna gniazda zaworu sterującego (b) [16]

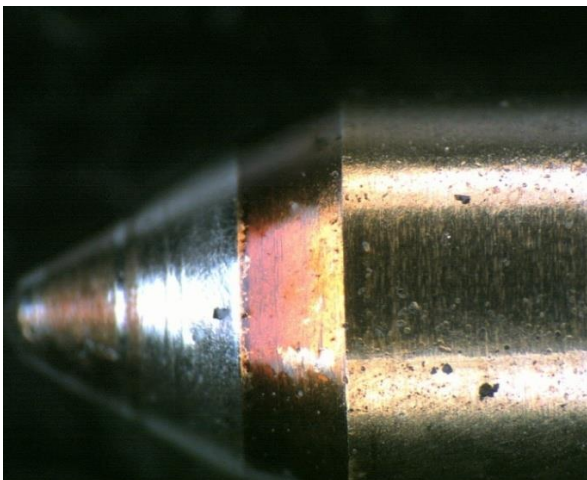
Fig. 8. Deep pitting corrosion of the needle (Bosch Common Rail nozzle) [16]  
 Rys. 8. Głęboka korozja wżerowa iglicy (rozpylacz Common Rail Bosch) [16]

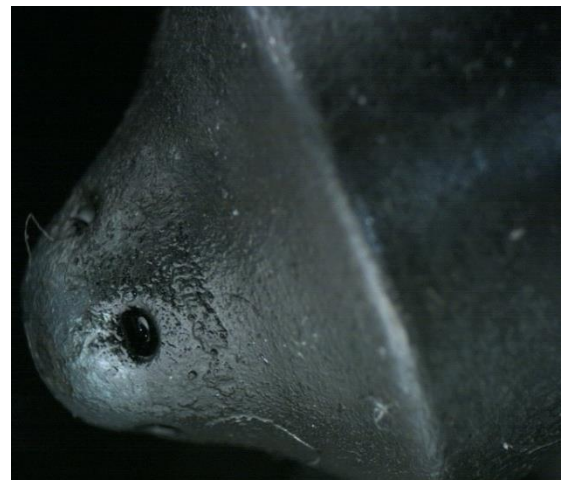
Fig. 9. Carbon in the area of nozzle holes (Bosch Common Rail nozzle) [16]  
 Rys. 9. Nagar w rejonie otworów rozpylających (rozpylacz Common Rail Bosch) [16]

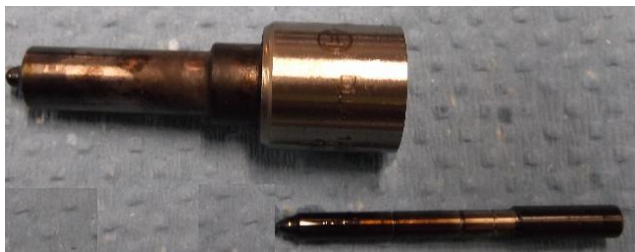
Fig. 10. Nozzle - there are visible signs of strong overheating of the nozzle in the form of brown discoloration, which caused seizure of the needle and blockage of the fuel flow [16]

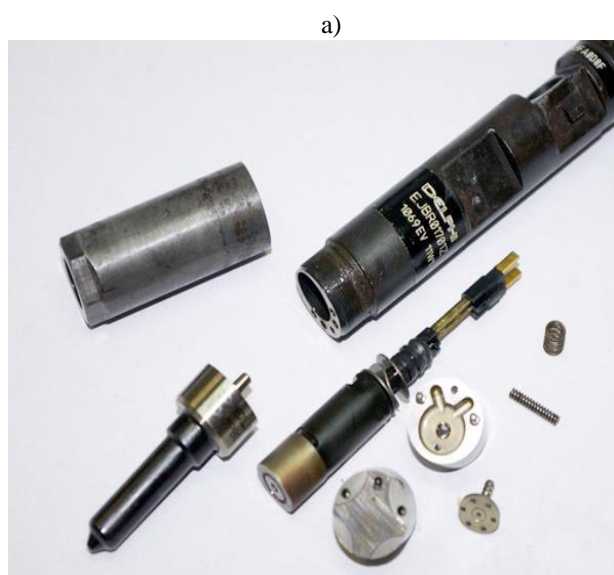
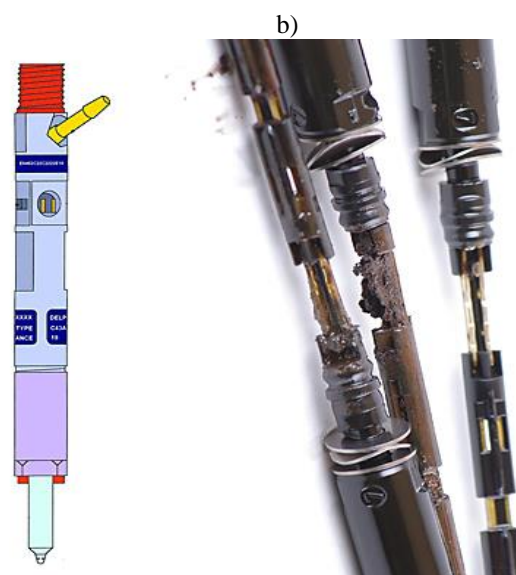
Fig. 12. Components of the injector (a), damaged coil of the piezo injector (clear traces of corrosion and loss of material caused by water entering the coil through leaking seals (b) [16]

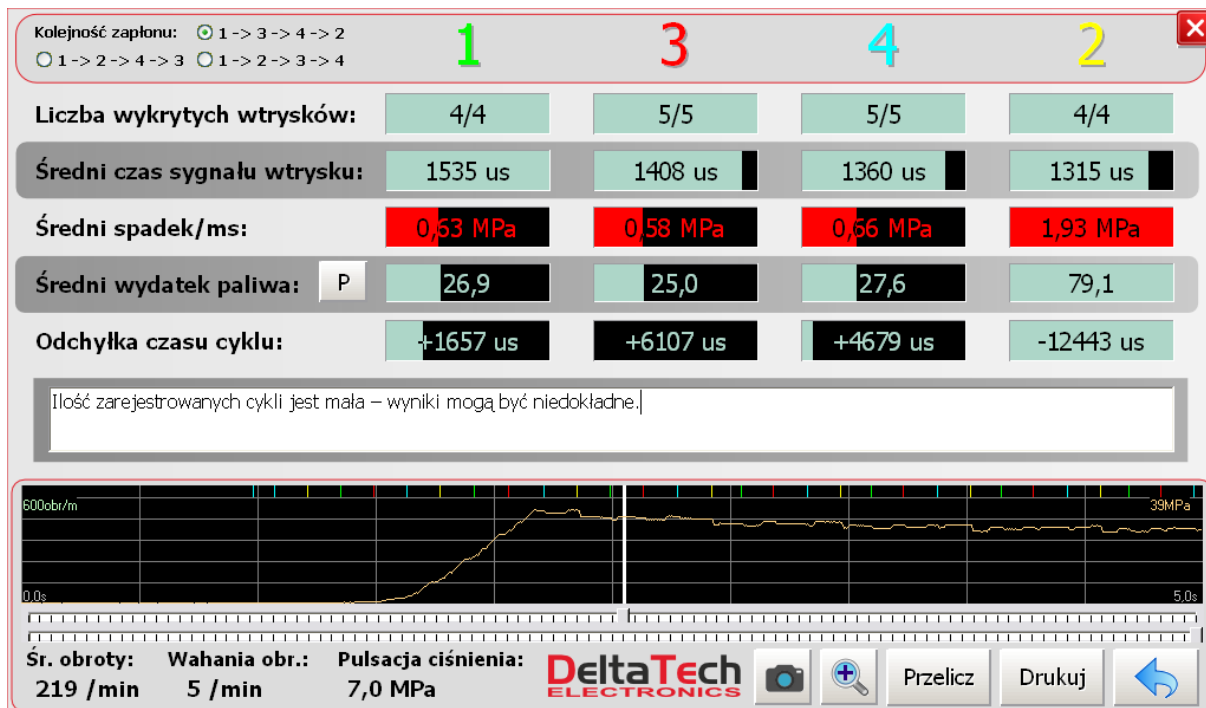
Fig. 15. Table of parameters - automatic analysis - diagnostic inference - obstructed injectors after improper regeneration, only injector No. 2 works properly [17]
