## CORROSION OF AISI 304L (EN 1.4307) STAINLESS STEEL IN ANIMAL SLURRY

## KOROZJA STALI AISI 304L (EN 1.4307) W GNOJOWICY

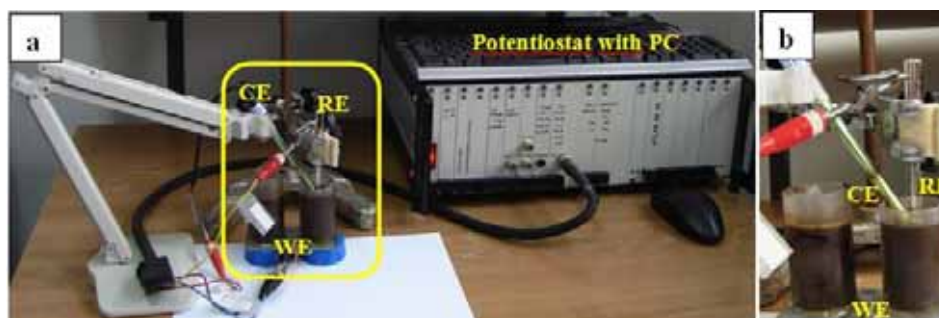
Fig. 1. Set up for potentiodynamic measurements of AISI 304L (EN 1.4307) in animal slurry (a), zoom of the electrochemical cell with counter (CE), reference (RE) and working (WE) electrodes (b)

The polarization scan rate was performed on potentiostat ATLAS 98 (Fig. 1a) at the scan rate of 0.1 mV·s<sup>-1</sup> in the direction of anode and 1 mV·s<sup>-1</sup> in case of reverse scan using SCE. Start of the scanning was done starting from -600 mV vs. SCE to the limit of current density at 1000  $\mu\text{A}\cdot\text{cm}^{-2}$  and a reverse scan back to the intersection with the plateau range of anodic curve was performed. All the polarization measurements were made after a one-hour samples keeping immersed in the animal slurry solution. The potentiodynamic studies were performed on AISI 304L (EN 1.4307) stainless steel without additional treatment (as received sheets of the material from ironworks). The composition of the stainless steel used is shown in Table 1.

The platinum electrode EPtP-301 (the plate of dimensions: 4×5 mm) was used as a counter electrode (CE), a saturated calomel electrode EK 101 (+0.244 V in 25 °C) was used for a reference (RE), and the studied stainless steel plate (Fig. 1b) was the working one (WE). The cell was placed perpendicularly to the sample surface (see Fig. 1).

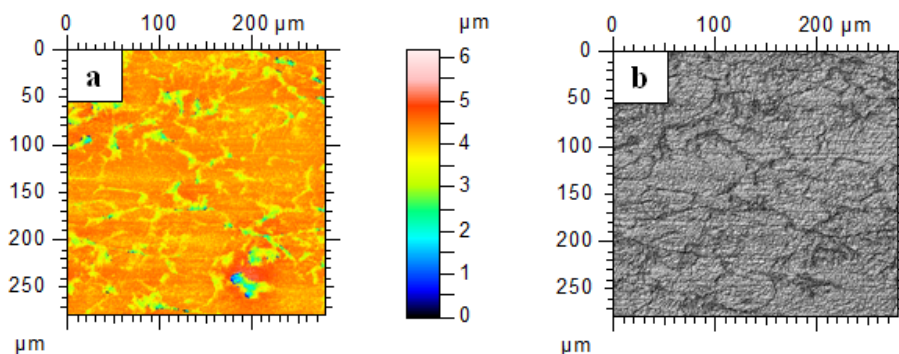
Fig. 3. 3D surface analysis of AISI 304L (EN 1.4307) as received, colour image (a), photo simulation (b)

The 3D roughness parameters were measured according to the standard ISO 25187. In Figure 3b there is shown the photo simulation to illustrate the measured surface. On the basis of the performed analyses there were calculated 3D surface roughness parameters:

$S_a = 0.349 \mu\text{m}$  (Arithmetic Mean Deviation of the Surface),  
 $S_q = 0.49 \mu\text{m}$  (Root-Mean-Square Deviation of the Surface),  
 $S_p = 2.17 \mu\text{m}$  (Maximum height of summits),  
 $S_v = 4.26 \mu\text{m}$  (Maximum depth of valleys),  
 $S_t = 6.43 \mu\text{m}$  (Total height of the surface).

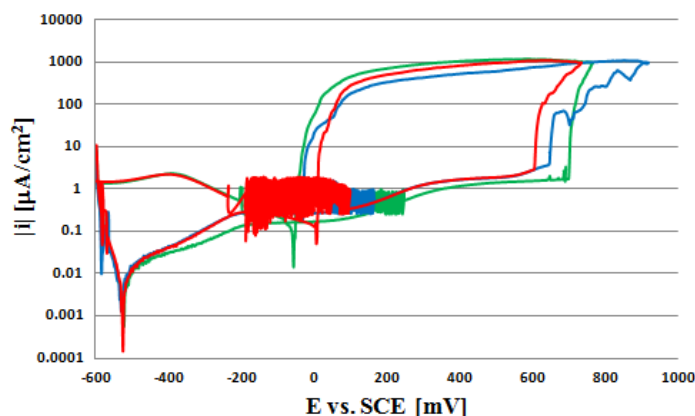
Fig. 4. Potentiodynamic results of AISI 304L SS (EN 1.4307) austenitic stainless steel immersed in animal slurry solution

In Figures 4 and 5 there are presented polarization results from potentiodynamic corrosion measurements.

It is clearly visible that the tendency to general corrosion is higher in case of the animal slurry than in 3% NaCl solution. Corrosion potential in the animal slurry is equal  $-525$  mV vs. SCE and for measurements in 3% NaCl it is about  $-200$  mV vs. SCE. On the other hand, the potential at plateau region,  $0$  mV vs. SCE for animal slurry amounts to the current density of about  $0.17 \mu\text{A}\cdot\text{cm}^{-2}$  and for 3% NaCl, about  $0.02 \mu\text{A}\cdot\text{cm}^{-2}$ . Thus it appears, the corrosion rate of AISI 304L (EN 1.4307) in the animal slurry is about 8.5 times higher than that in 3% NaCl (the most aggressive aqueous sodium chloride solution). On the other hand, there is pitting potential which for the animal slurry is very high (average of about  $700$  mV vs. SCE) versus that one in 3% NaCl (on average of about  $300$  mV vs. SCE), what could suggest a higher pitting corrosion resistance.

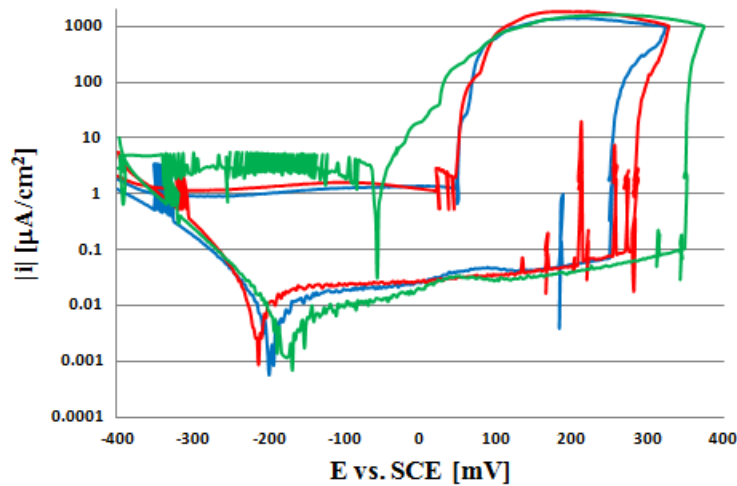
Fig. 5. Potentiodynamic results of AISI 304L (EN 1.4307) austenitic stainless steel submerged in 3% NaCl water solution  
 Rys. 5. Wyniki z badań potencjodynamicznych na stali stopowej austenitycznej AISI 304L SS (EN 1.4307) w 3% wodnym roztworze chlorku sodu (NaCl)
